Poseidon Rescue Baby Bag PRBB1203
Test Report No: TR2018-011
Date: 5/09/2018

QSI Static Pull Test

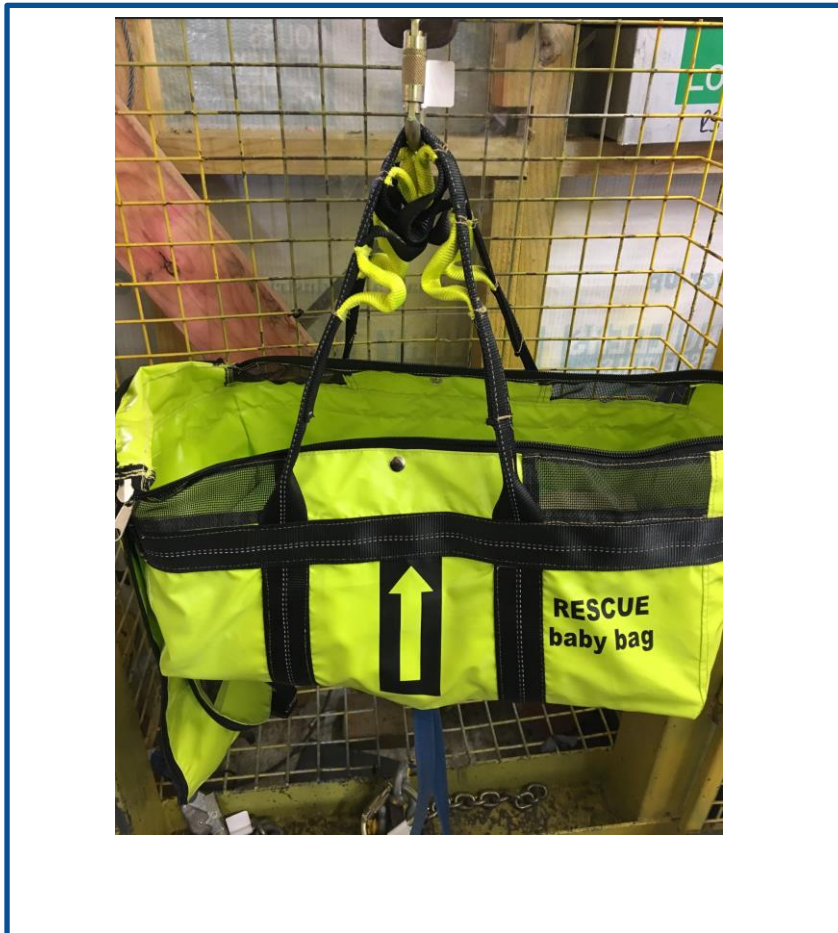
- **PRBB1203 Rescue Baby Bag**

Product:	PRBB1203 Rescue Baby Bag
Specifications:	FR PVC Lime Bag with rated webbing handles
Supplied Safe Work Load Limit:	25kg
Distributor:	Static Load test requested by Poseidon

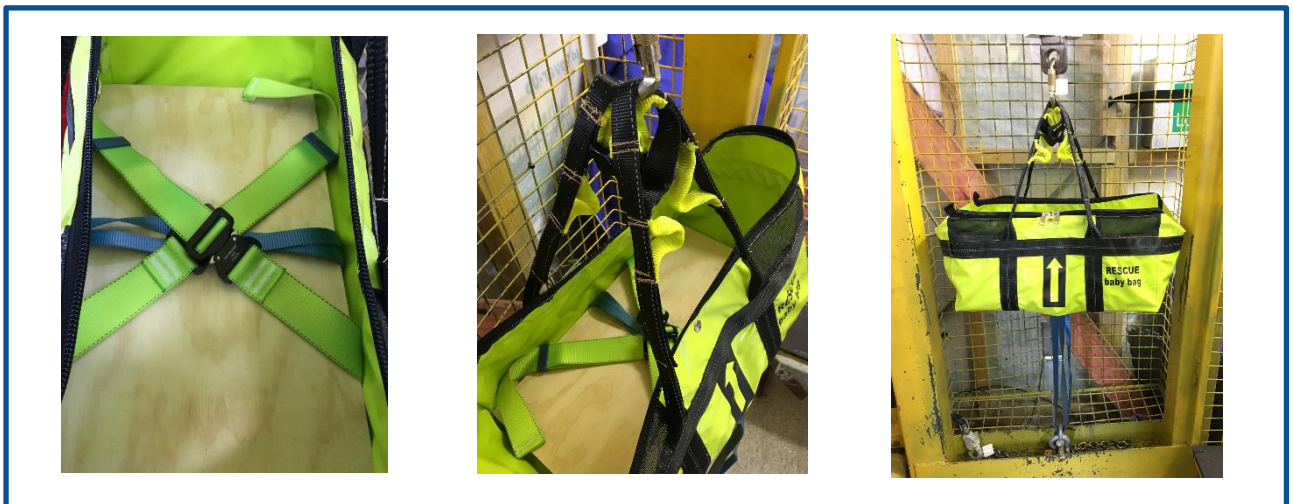
1. Insert a 21mm Laminated Ply-board in the base of the bag (Cut Board Slightly smaller than inside of the bag).
2. Cut through the base of the PVC on either side of the bag to allow you to put a 1.5-ton sling around the board.
3. Connect the rated bag lifting handles to the load cell at the top of the pull test rig, and the 1.5-ton sling to the anchor at the base of the test rig.
4. There is no requirement for conditioning of the bag.

Designation / Attachment Points	Test	Description
The bag is statically loaded between a top hydraulic arm and a bottom anchor in the static pull test rig	Static pull	Test 1 Static pull to 10 x times SWL – Required load 250kg for 3 minutes TEST 2 Static pull to 12kN for 1 minute

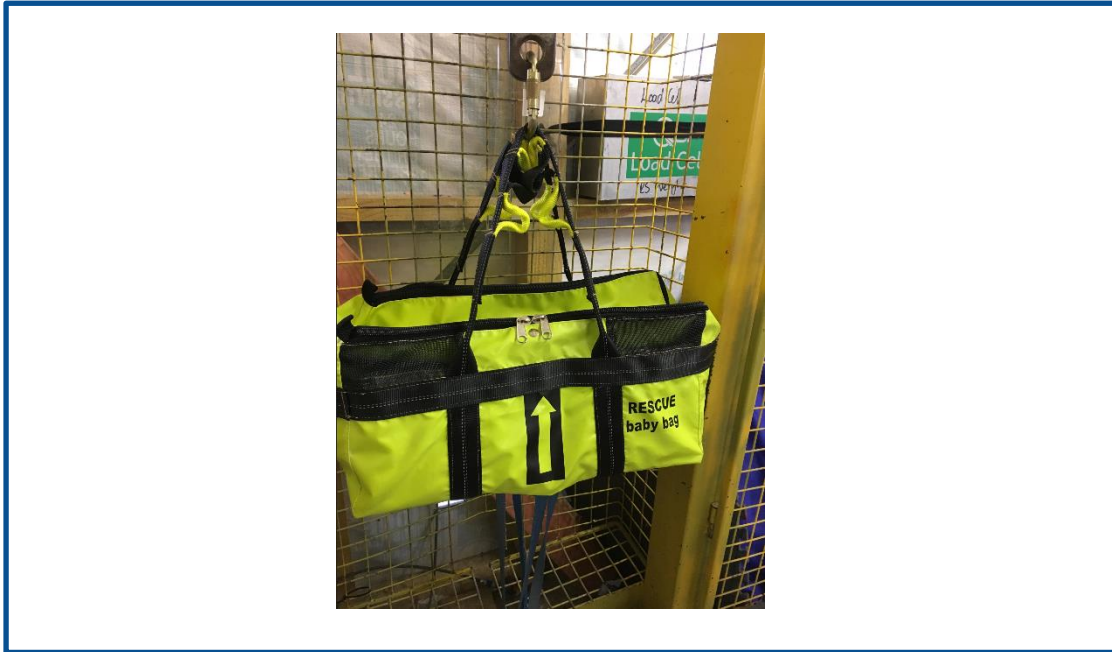
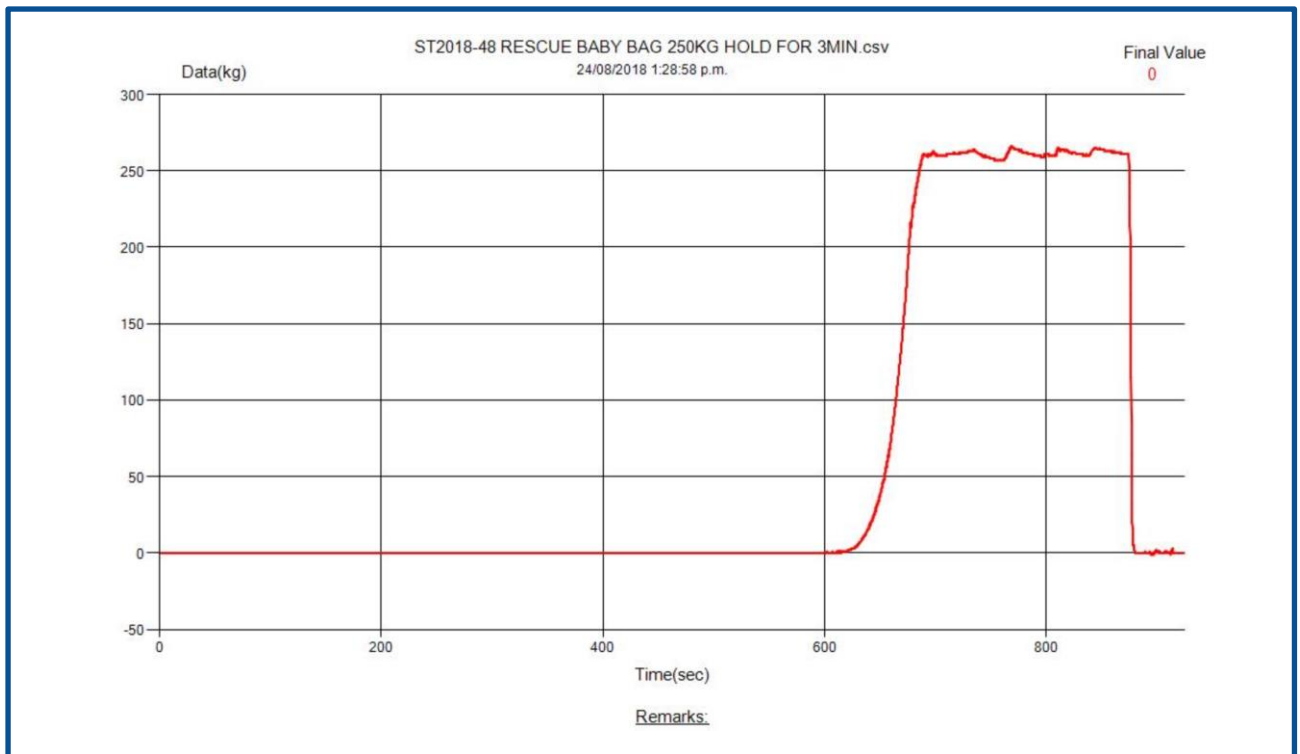
Test number 1:- ST2018-48 (Static Load 250kg on Rescue Baby Bag)

When subjected to the static load of ten times the safe workload limit, the load must be maintained for 3 minutes and there must be no signs of any major structural stitch failure.

250kg = >2.45 kN

Result: Passed

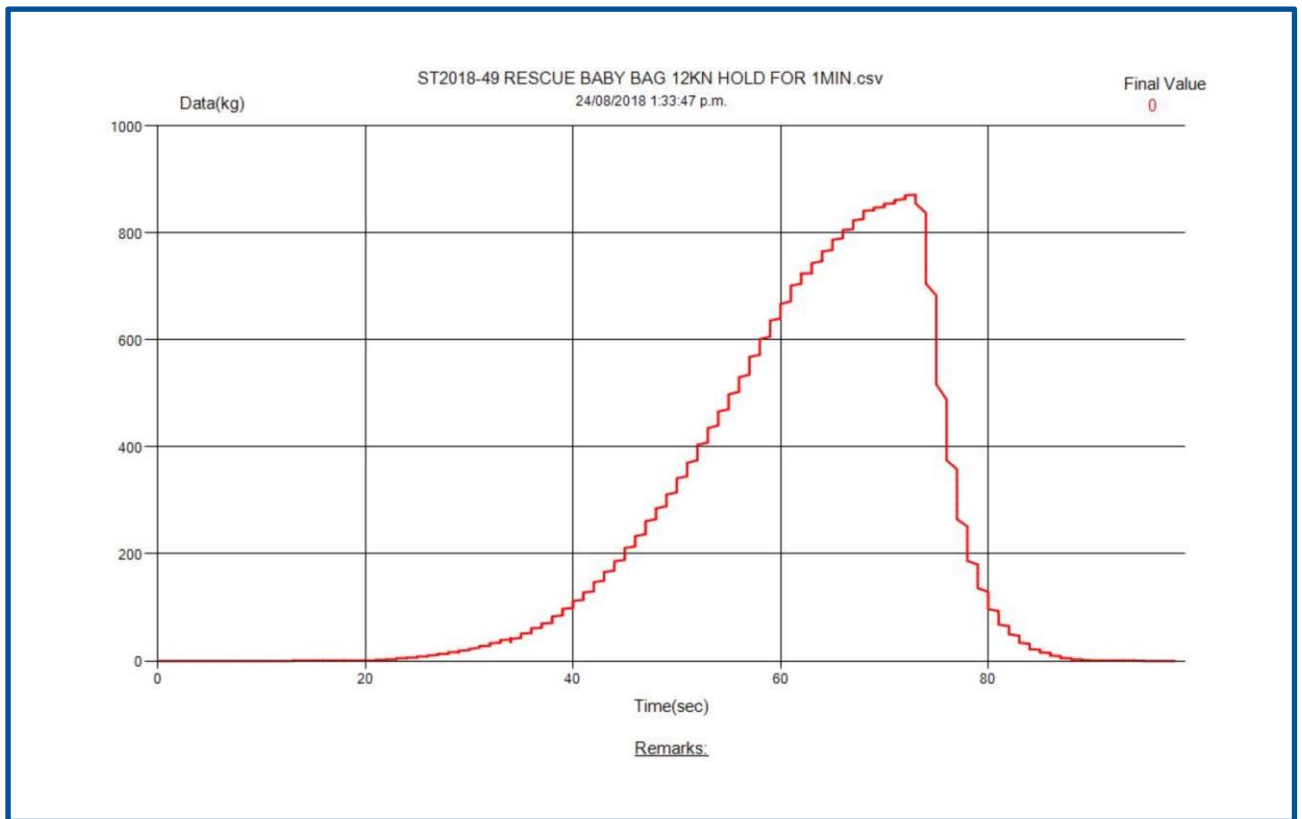
Test number 2:- ST2018-49 (Static Load 12kN on Rescue Baby Bag)

The second test was to push the Rescue Baby Bag beyond its ten times safety factor. Although it did not reach the pre-determined target of 12kN before some seams started separating under the force, the testing team were comfortable with the 8.53kN load obtained. As 870kg's is still a lot of additional carrying capacity when only 25kg's is required.

- The test specimen Poseidon PRBB1203 Rescue Baby Bag was able to operate at ten times the safe working load limit of 25kgs.
- At 870kgs of force, the rescue baby bag was still intact, just the PVC portion started to show signs of stress, the webbing portion was still holding well.
